**WORLD BREWING CONGRESS**

# Establishing a Supplier Quality Program

Aaron Golston

Quality Manager – Chicago  
Lagunitas Brewing Company

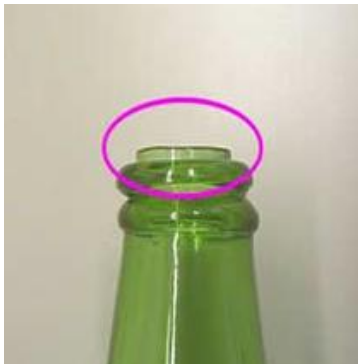
Overpress

- Ask vendor for terms and common lists of defects
  - Understand severity of defects
  - Speak the same language
